INCIDENT INVESTIGATION REPORT

HERITAGE-WTI INCINERATOR INCIDENT

APRIL 12, 2011

Final Report
May 31, 2011

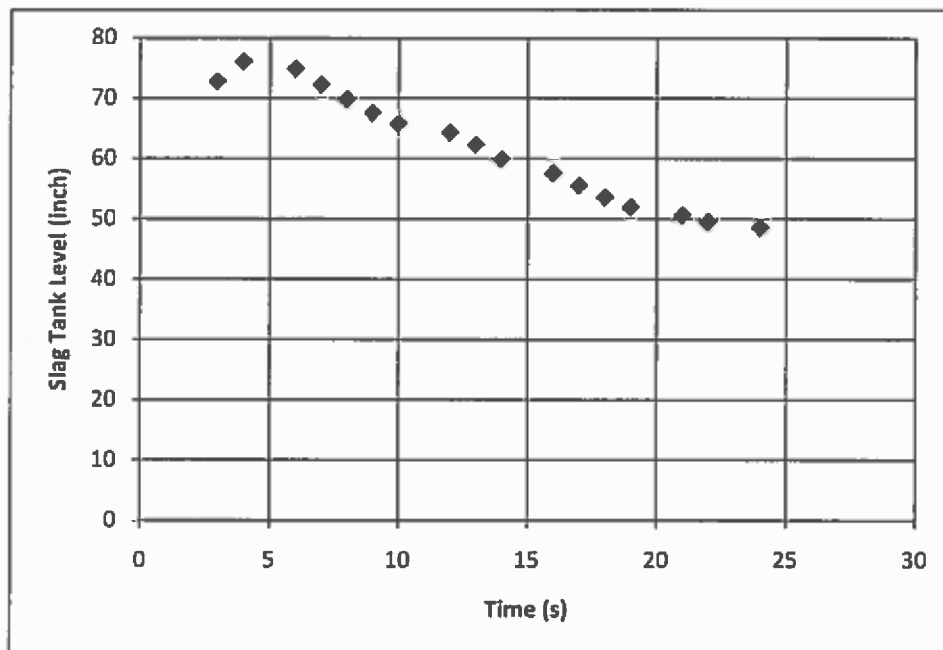
Figure 3. Slag Tank Liquid Level as a Function of Time

The liquid level in the quench tank rose suddenly and then fell, as shown in Figure 3. The liquid level in the tank dropped more than 20 inches. The splashing of water out of the tank also threw drums and ash from the slag tank. Several inches of ash were on the ground surrounding the tank following the incident.

- WTI may consider adding a temperature sensor in the slag tank.

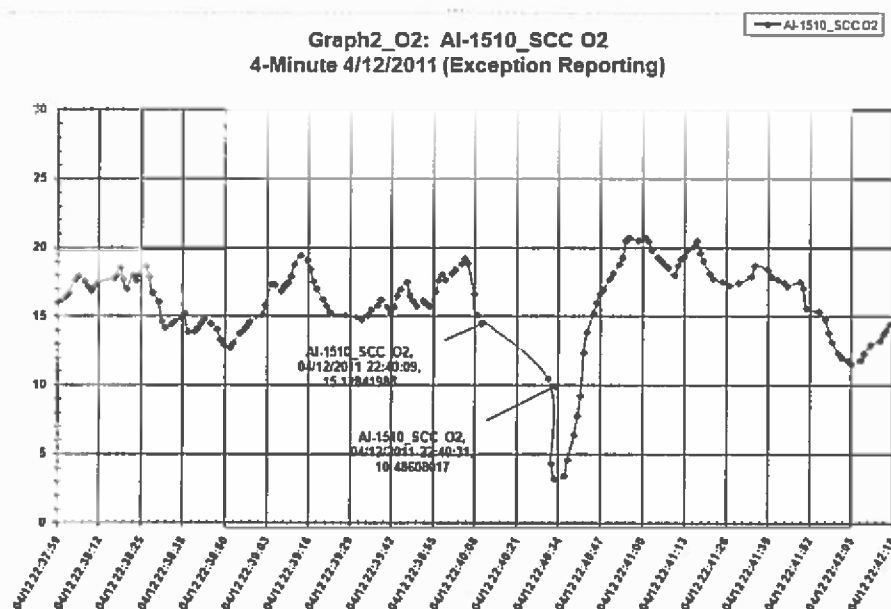
Figure 4. SCC Oxygen Concentration as a Function of Time

The oxygen concentration dropped suddenly in the SCC (as shown in Figure 4), below the 12% needed for combustion. This was caused mainly by the sudden vaporization of water from the slag tank and creation of steam, which displaced the oxygen in the combustion air.

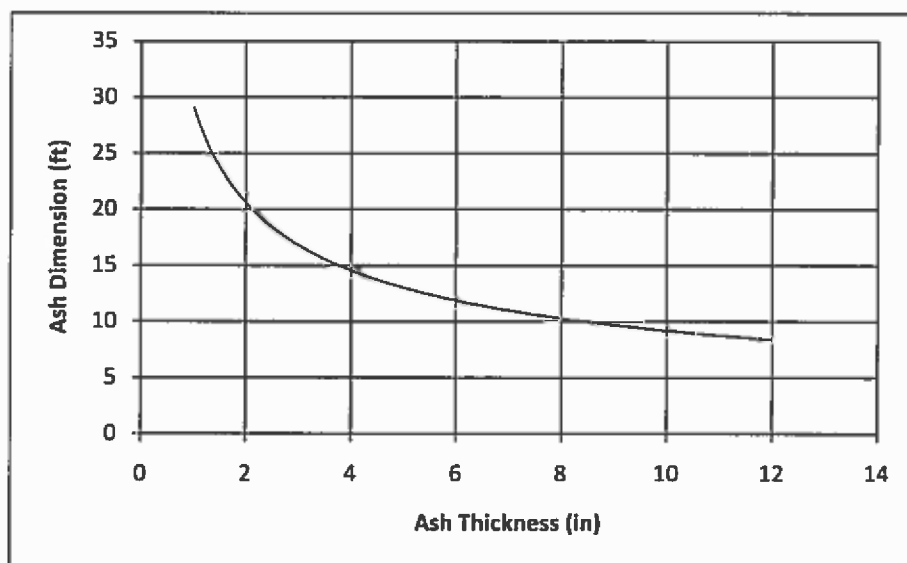
Figure 5. SCC Ash Size Consistent with Water Level Change

BakerRisk suggests that the water was removed by splashing. Equating the momentum of ash falling from the SCC to the momentum needed to splash the water from the tank produces the curve shown in Figure 5. This chart shows the approximate dimension of a square piece of ash dropped from the top of the SCC (46 ft, assuming an ash specific gravity of 2) that would

produce the observed water displacement. This is a reasonable explanation of the loss of water from the slag tank.
